SMITHSONIAN INSTITUTION
BUREAU OF AMERICAN ETHNOLOGY
BULLETIN 121

ARCHEOLOGICAL REMAINS IN THE
WHITEWATER DISTRICT
EASTERN ARIZONA

PART I. HOUSE TYPES

By FRANK H. H. ROBERTS, JR.

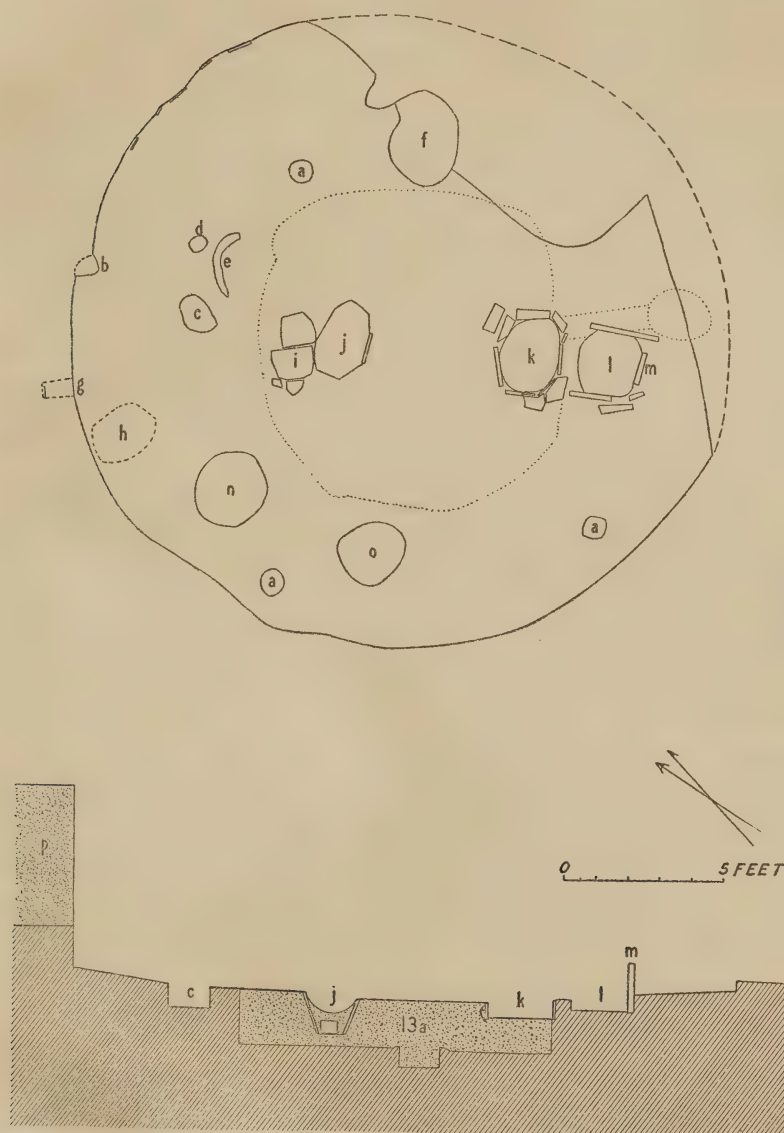
FIGURE 31.—Structure 13b. *a*, holes for main support posts; *b*, beam placement; *c* and *d*, storage holes; *e*, groove in floor; *f*, storage basin; *g*, wall pocket or Katsina niche; *h*, basin covered by floor plaster; *i*, stones embedded in floor; *j*, basin in floor; *k*, fire pit; *l*, ladder box; *m*, deflector stone; *n* and *o*, storage basins; *p*, drift sand. Dotted lines show position of 13a.

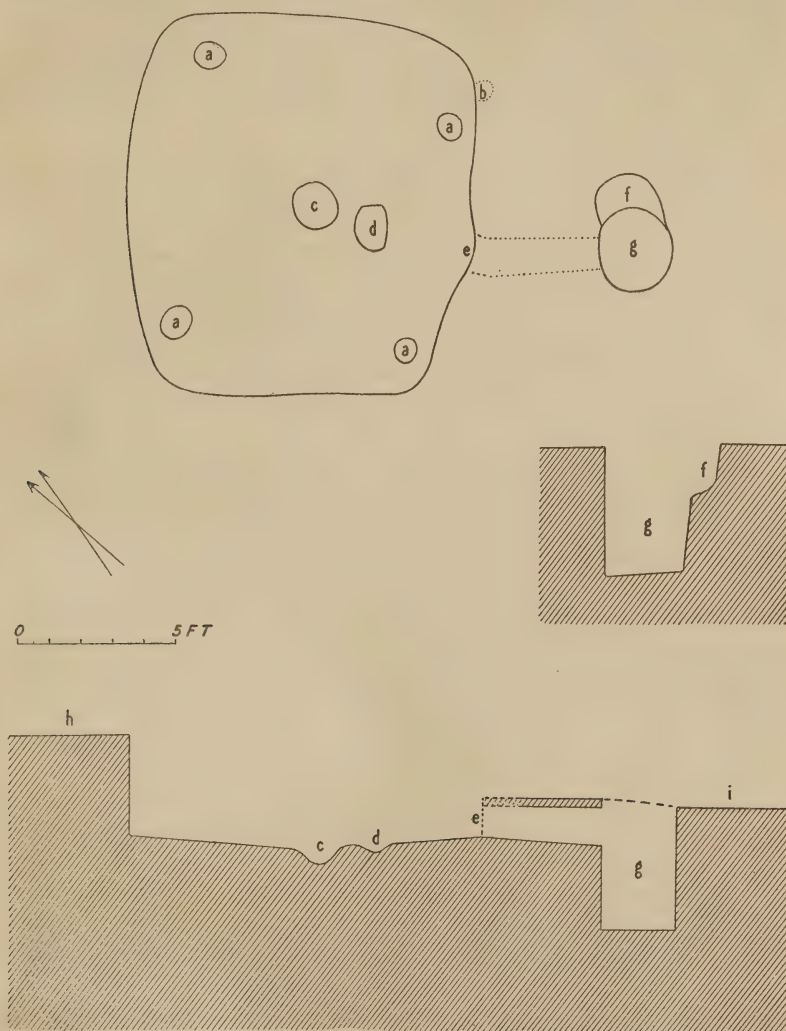
FIGURE 32.—Structure 14. *a*, holes for main support posts; *b*, wall pocket; *c*, fire pit; *d*, ladder box; *e*, ventilator opening; *f* and *g*, exterior opening to ventilator shaft; *h*, platform of dance court dais; *i*, floor of dance court.

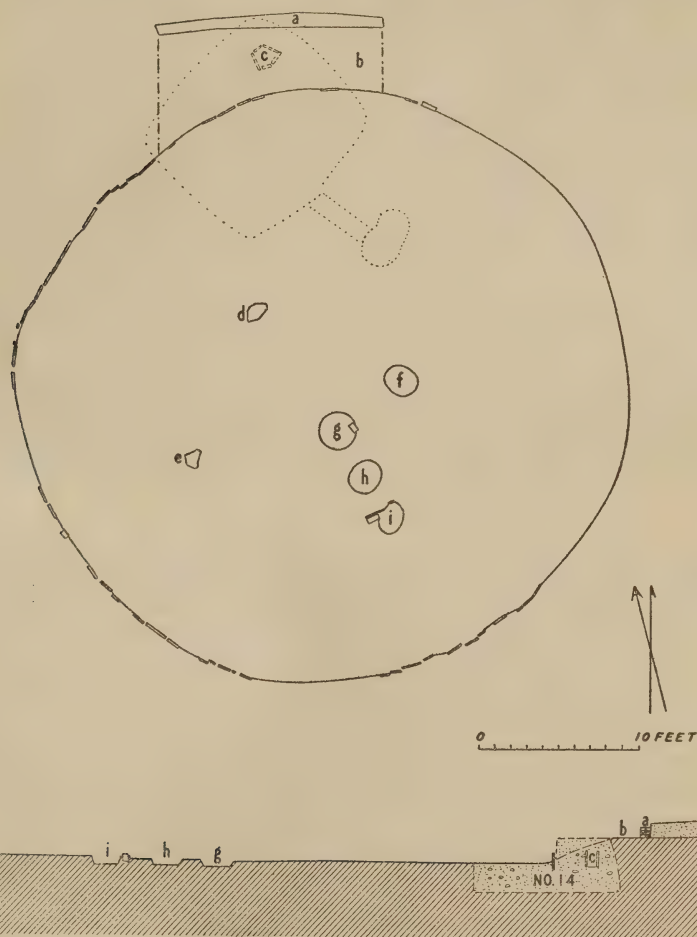
FIGURE 33.—Dance court. *a*, masonry wall; *b*, dais; *c*, fire pit; *d* and *e*, stones embedded in floor; *f*, basin in floor; *g*, fire pit; *h*, ash pit; *i*, basin in floor. Dotted lines show location of structure 14.

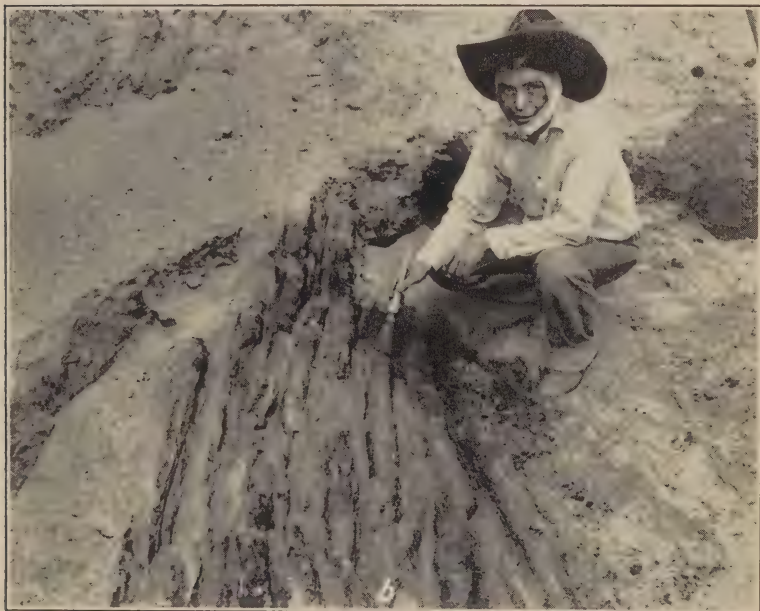
b. Series of slanting side poles for roof of structure 15.

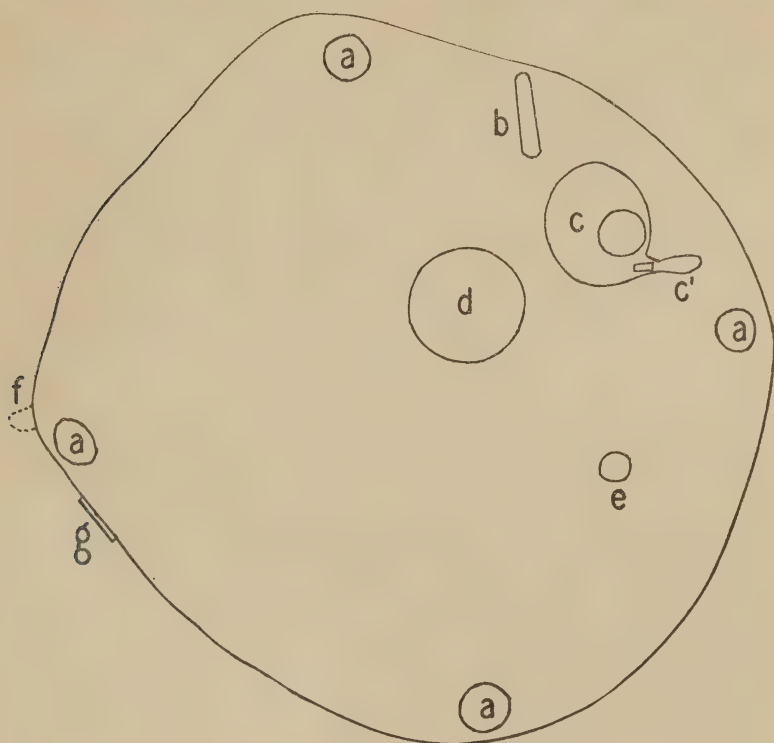
FIGURE 34.—Brush shelter. *a*, holes for support posts; *b*, stone in floor; *c*, storage pit in floor; *d*, fire pit; *e*, storage hole in floor; *f*, placement for roof brace; *g*, slab in wall.

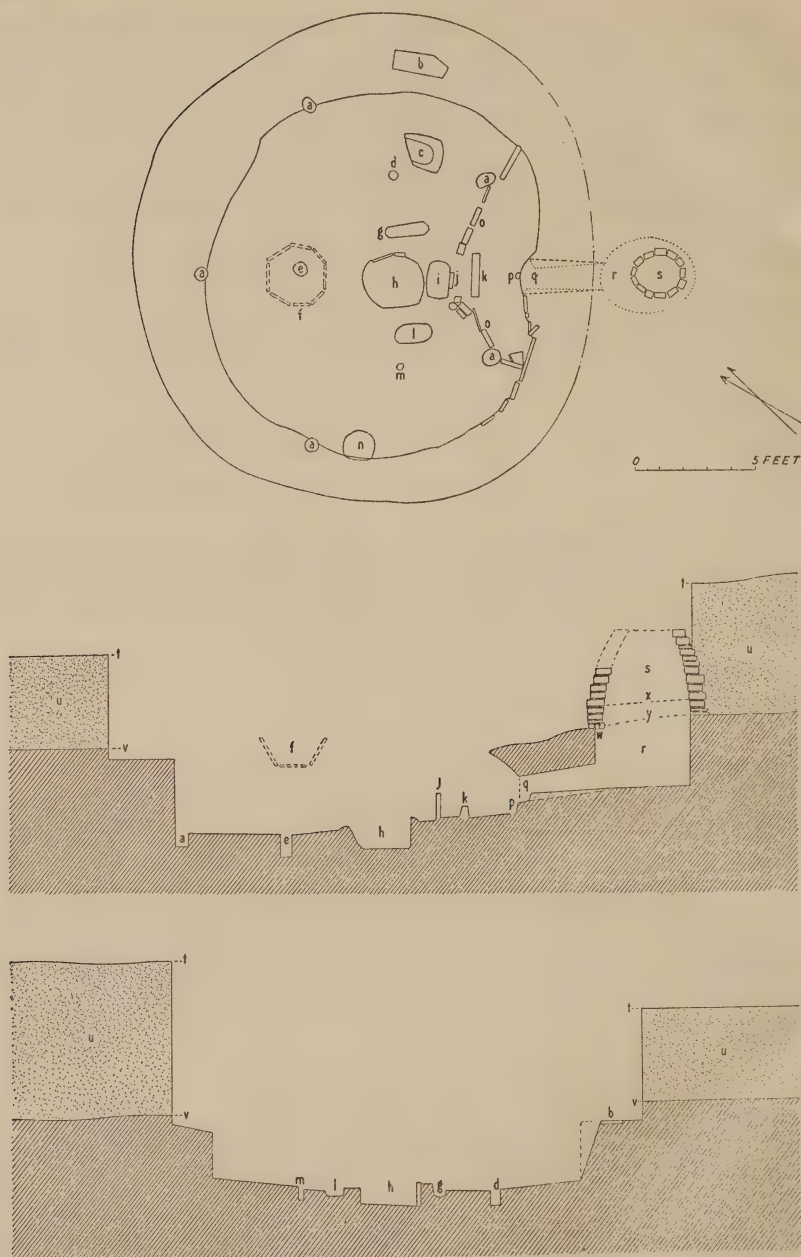
FIGURE 36.—Structure 15. *a*, holes for support posts; *b*, stone embedded in bench top; *c*, metate on floor; *d*, small storage hole; *e*, sipapu; *f*, fire pit; *g*, basin in floor; *h*, fire pit; *i*, ash pit; *j*, deflector; *k*, step and ladder brace; *l*, basin in floor; *m*, storage hole in floor; *n*, storage basin; *o*, compartment wall; *p*, hole for post to brace cover stone; *q*, ventilator opening; *r*, base of ventilator shaft; *s*, ventilator opening on ground; *t*, present surface; *u*, sand accumulation; *v*, original surface; *w*, wooden support for masonry; *x*, floor in granary; *y*, surface of accumulated material in shaft.

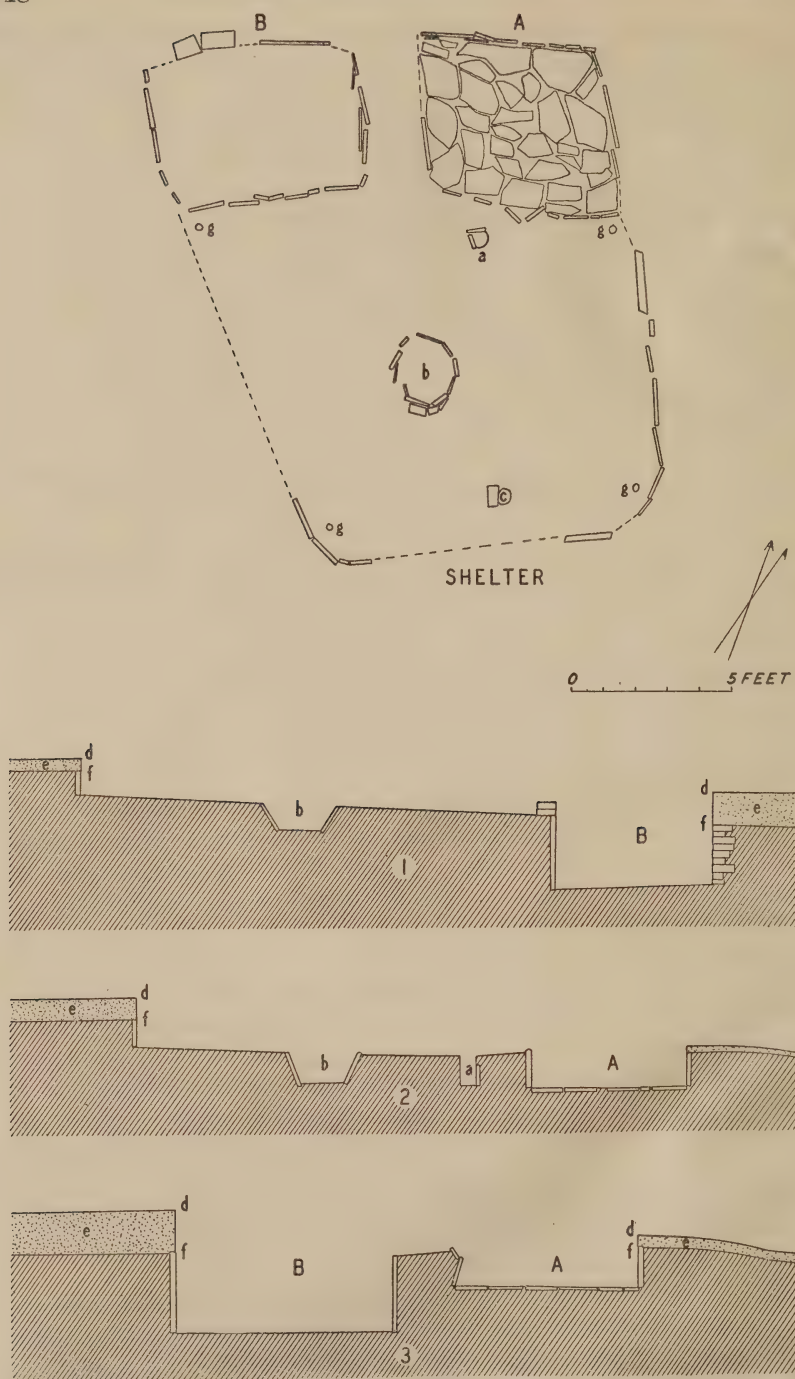
FIGURE 38.—Granaries A and B and shelter in No. 15 group. *a*, hole for support post; *b*, fire pit; *c*, hole for support post; *d*, present surface; *e*, sand fill; *f*, original surface; *g*, holes for corner supports for arbor.

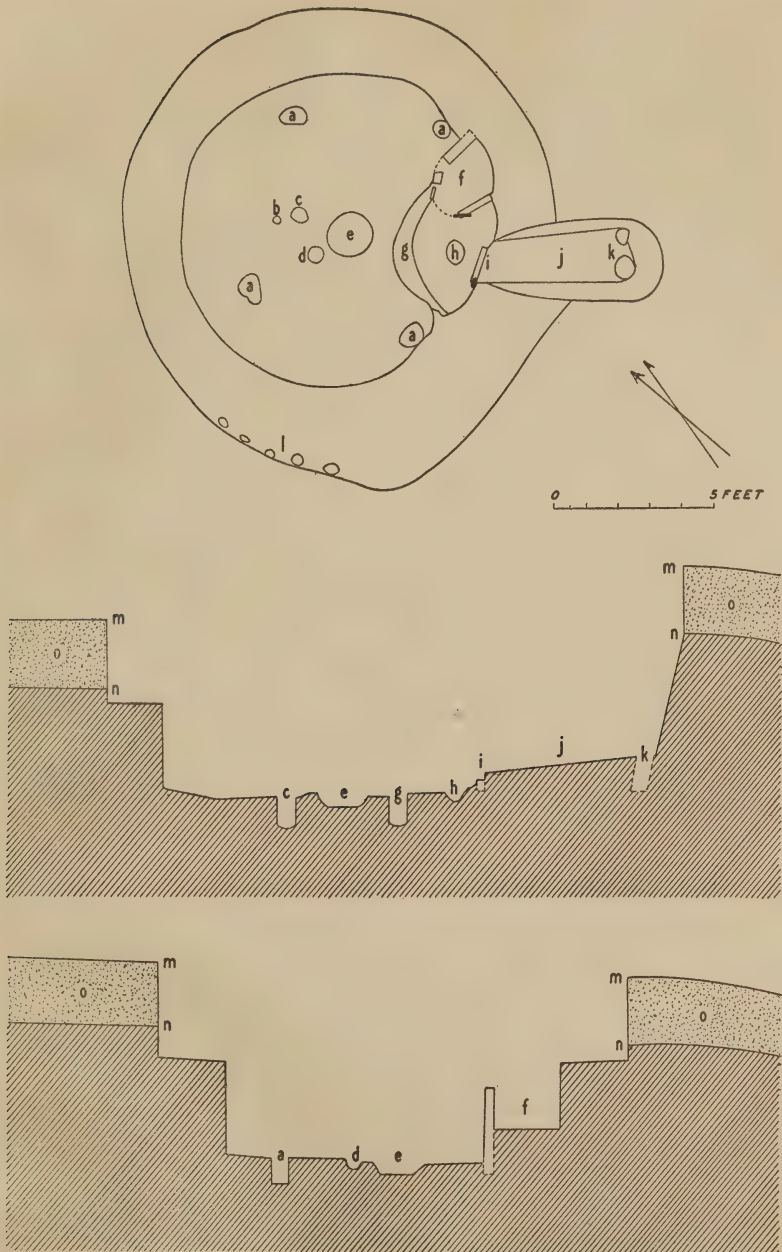
FIGURE 40.—Structure 16. *a*, holes for main roof supports; *b*, small storage hole; *c*, sipapu; *d*, pot rest; *e*, fire pit; *f*, storage bin; *g*, groove for compartment wall; *h*, basin in floor; *i*, sill in passage opening; *j*, passage; *k*, holes for ladder poles; *l*, placements for side poles; *m*, present surface; *n*, old surface; *o*, sand fill.

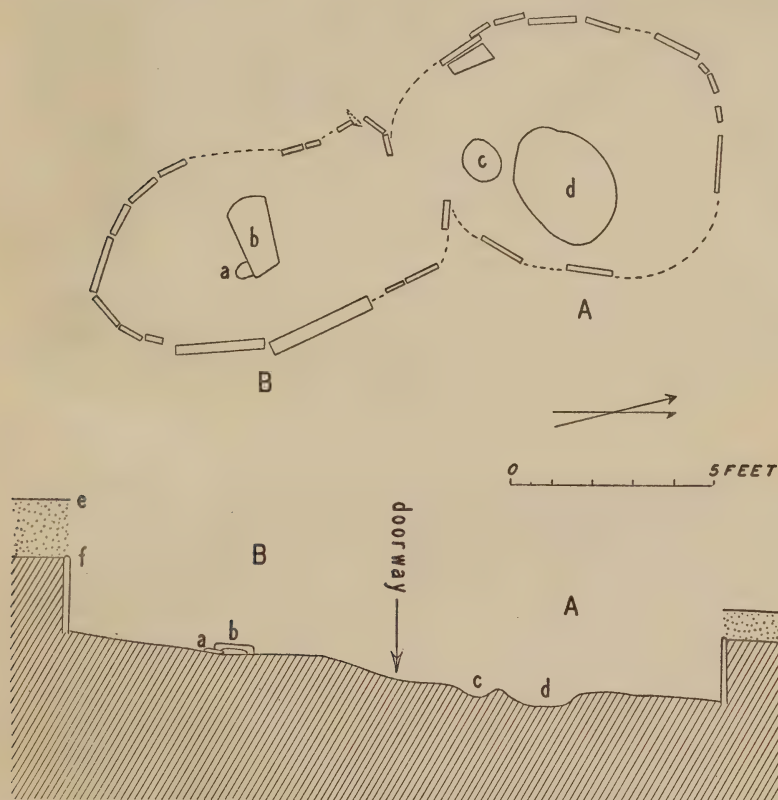
FIGURE 41.—Granaries A and B of the No. 16 group. *a*, mano or hand milling stone; *b*, metate stone; *c*, fire pit; *d*, storage basin; *e*, present surface; *f*, original ground level.

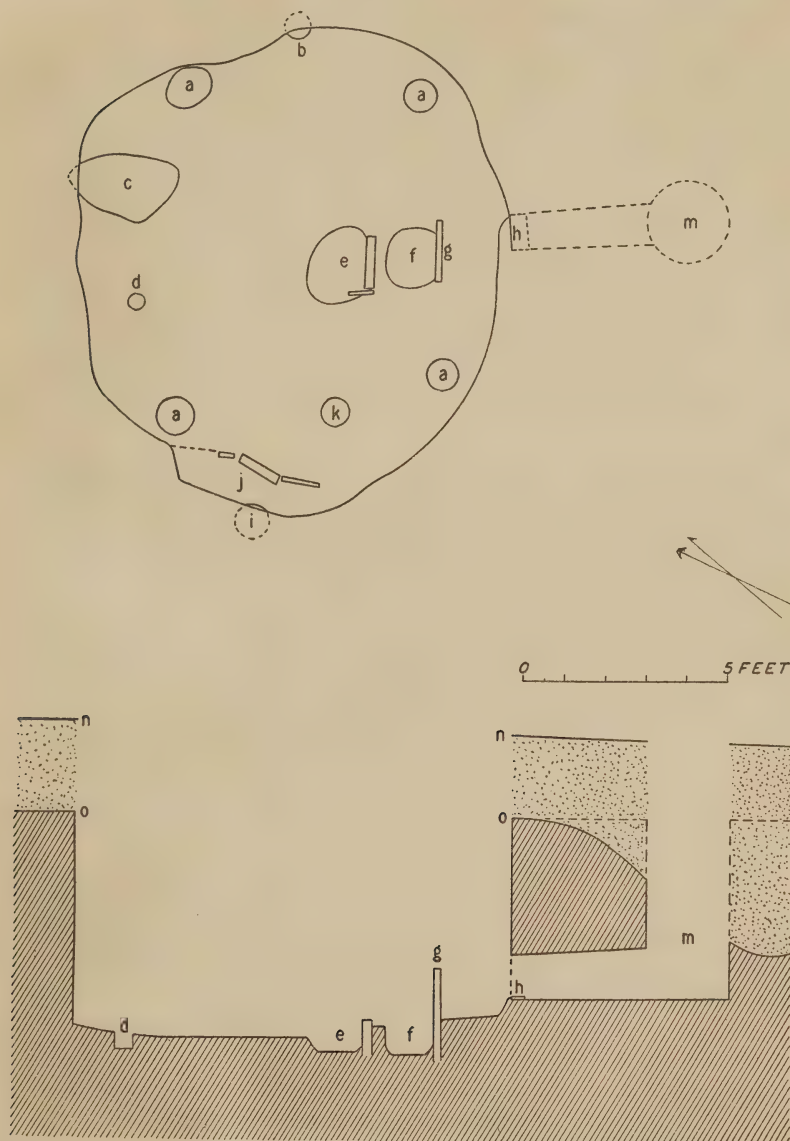
FIGURE 42.—Structure 17. *a*, holes for support posts; *b*, subwall pocket; *c*, storage pit; *d*, sipapu; *e*, fire pit; *f*, basin for ashes and ladder; *g*, deflector; *h*, sill in ventilator opening; *i*, subwall pocket; *j*, storage bin; *k*, pot rest; *m*, ventilator shaft; *n*, present ground level; *o*, original surface.

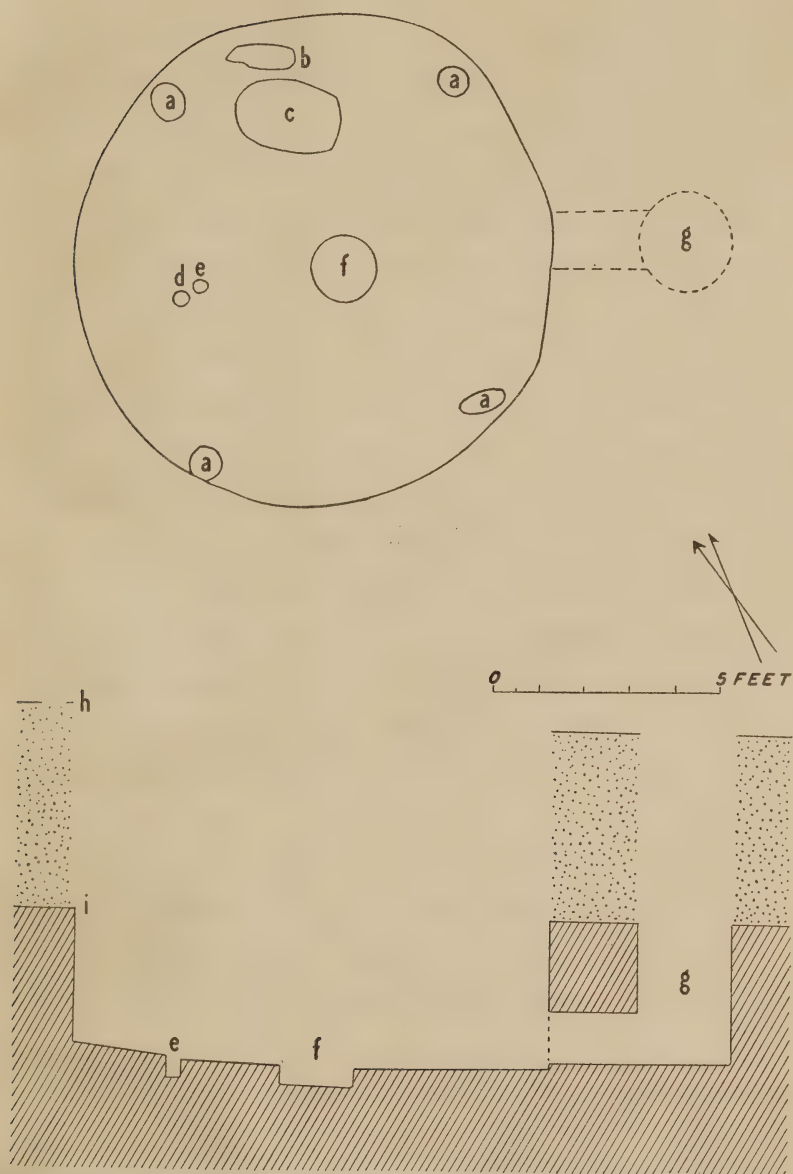
FIGURE 43.—Structure 18. *a*, holes for roof supports; *b*, storage pit in floor; *c*, storage basin; *d* and *e*, sipapus; *f*, fire pit; *g*, ventilator shaft; *h*, present surface; *i*, old ground level.

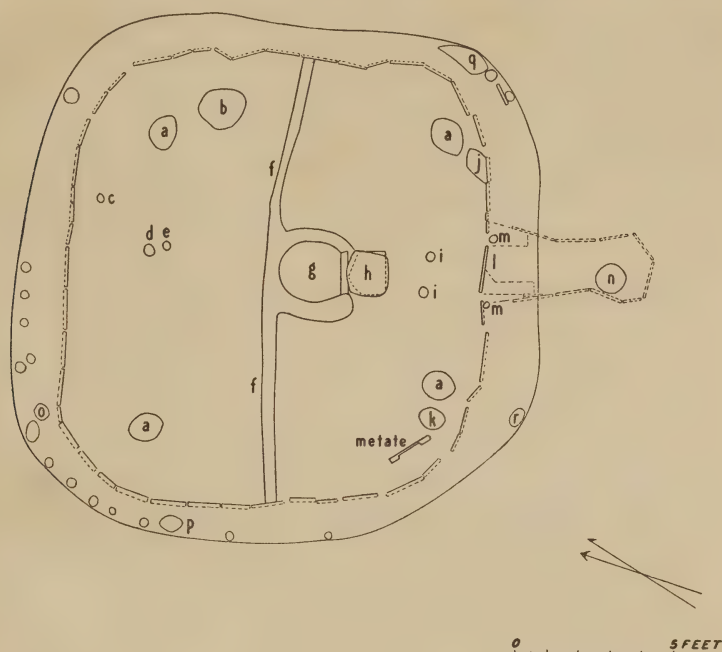
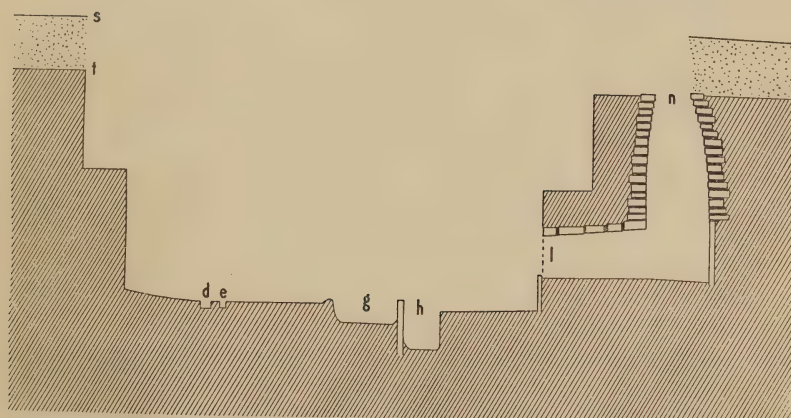
FIGURE 45.—Kiva A. *a*, holes for roof supports; *b*, storage pit; *c*, storage hole; *d* and *e*, sipapus; *f*, plaster ridge on floor; *g*, fire pit; *h*, old ladder pit; *i*, ladder pole depressions; *j*, storage pocket; *k*, pot rest or storage pocket; *l*, ventilator aperture; *m*, poles reinforcing ventilator opening; *n*, ventilator shaft; *o*, slanting timber placements; *p*, *q*, *r*, storage pockets on bench top; *s*, present surface; *t*, old ground level.

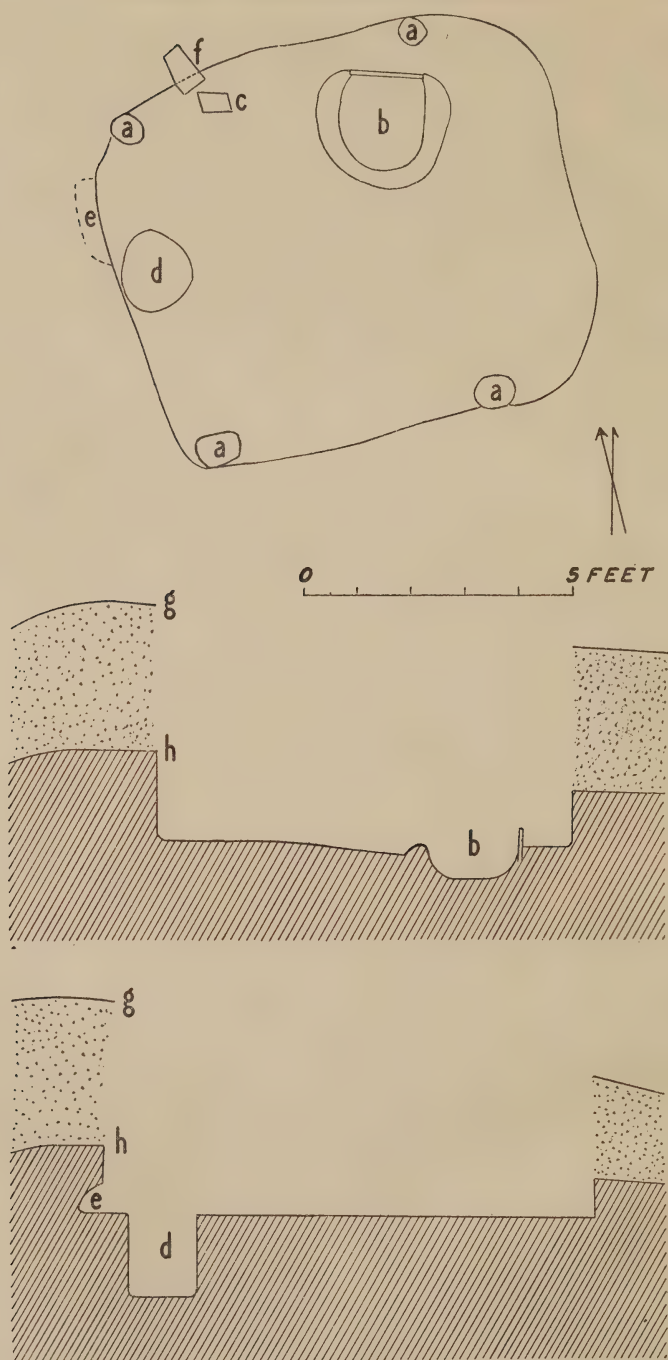
FIGURE 46.—Brush shelter. *a*, holes for roof supports; *b*, fire pit; *c*, stone step; *d*, storage pit in floor; *e*, subwall pocket; *f*, stone tread; *g*, present surface; *h*, old ground level.

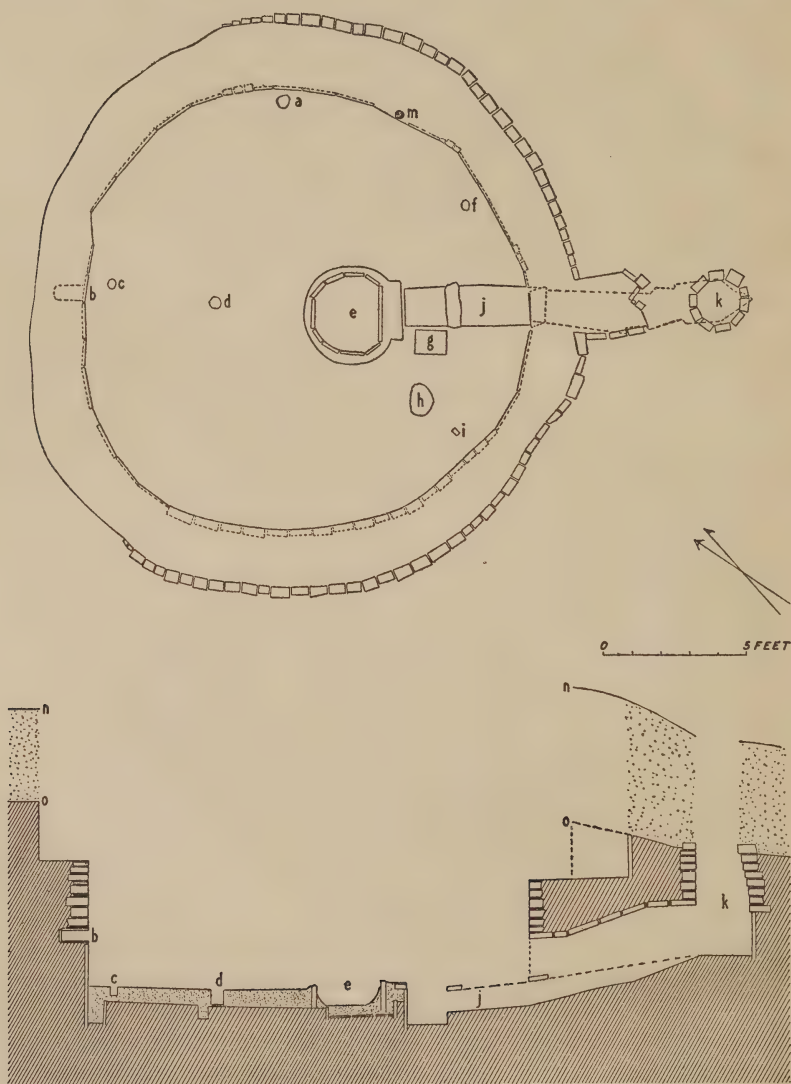
FIGURE 47.—Kiva B, upper floor level. *a*, storage hole in floor; *b*, Katchina niche; *c*, storage hole in floor; *d*, sipapu; *e*, fire pit; *f*, storage hole; *g*, ash pit; *h*, stone in floor; *i*, stone in floor; *j*, subfloor ventilator trench; *k*, ventilator shaft; *m*, post incorporated in bench; *n*, present ground level; *o*, original surface.

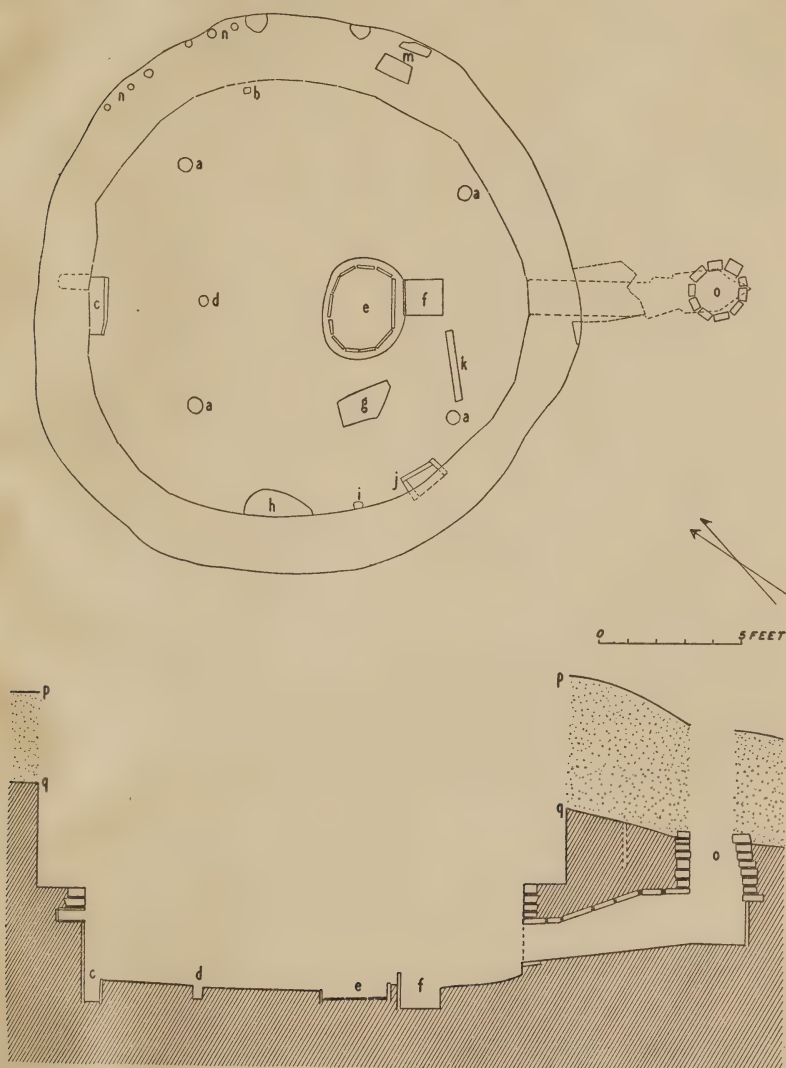
FIGURE 48.—Kiva B, original floor level. *a*, holes for main roof posts; *b*, stone in floor; *c*, storage box; *d*, sipapu; *e*, fire pit; *f*, ladder box; *g*, stone embedded in floor; *h*, storage pit; *i*, storage hole; *j*, subwall storage box; *k*, stone in floor; *m*, stones embedded on bench top; *n*, holes for slanting side poles; *o*, ventilator shaft; *p*, present ground level; *q*, original surface.

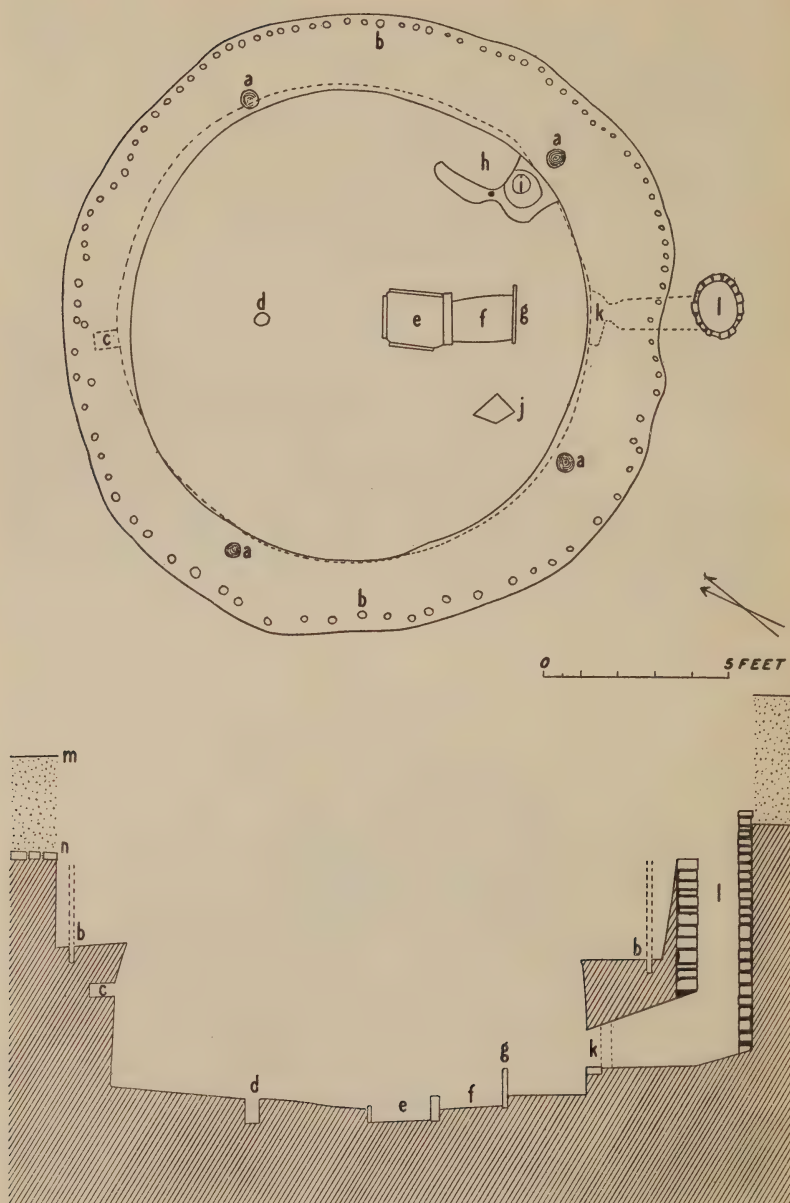
FIGURE 51.—Kiva for unit No. 3. *a*, posts incorporated in bench to reinforce wall; *b*, holes for poles forming wainscoting; *c*, Katchina niche; *d*, sipapu; *e*, fire pit; *f*, ash pit and ladder box; *g*, deflector; *h*, shallow basin in floor; *i*, small circular basin with stone bottom; *j*, stone embedded in floor; *k*, ventilator opening; *l*, ventilator shaft; *m*, present surface; *n*, old ground level.

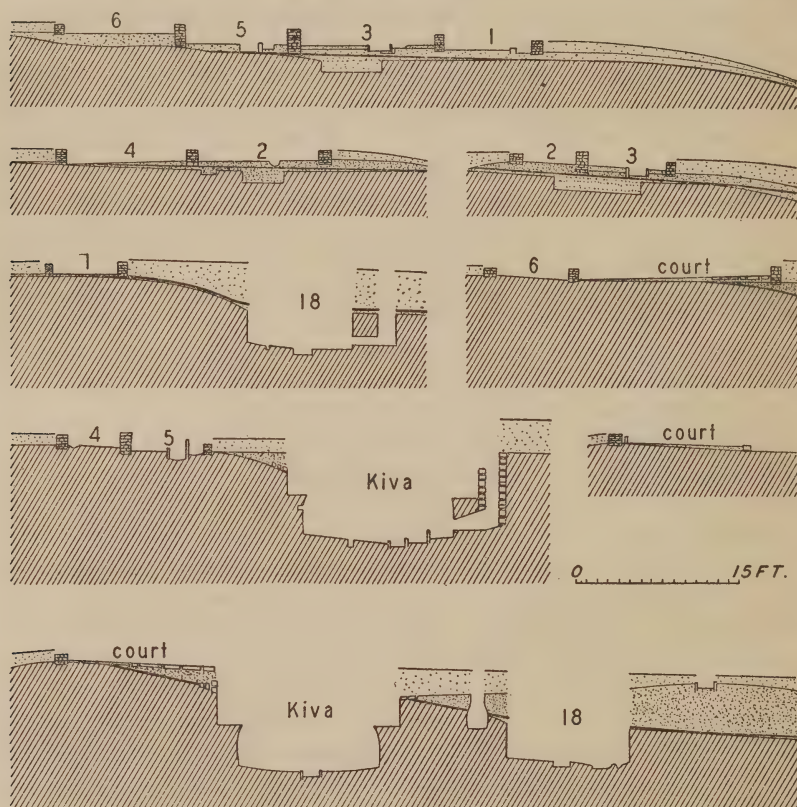
FIGURE 52.—Sections in third unit. Heavy line passing through fill indicates layer of red earth separating occupation level of pit structure and that of subsequent unit.
